Independent Investigation Exemplar 1 – Coastal Landscapes (includes marking commentary)

'A' LEVEL GEOGRAPHY PROJECT

Coastal Defence Management at Oldstairs Bay

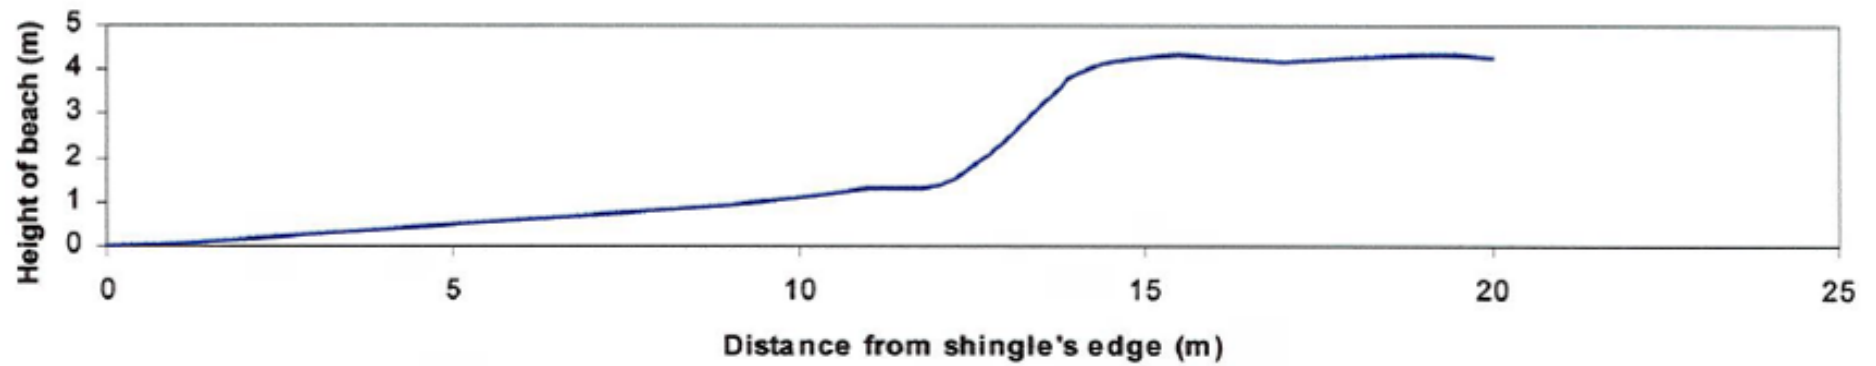
Transect 1. Leveling from shingle's edge to road at low tide.

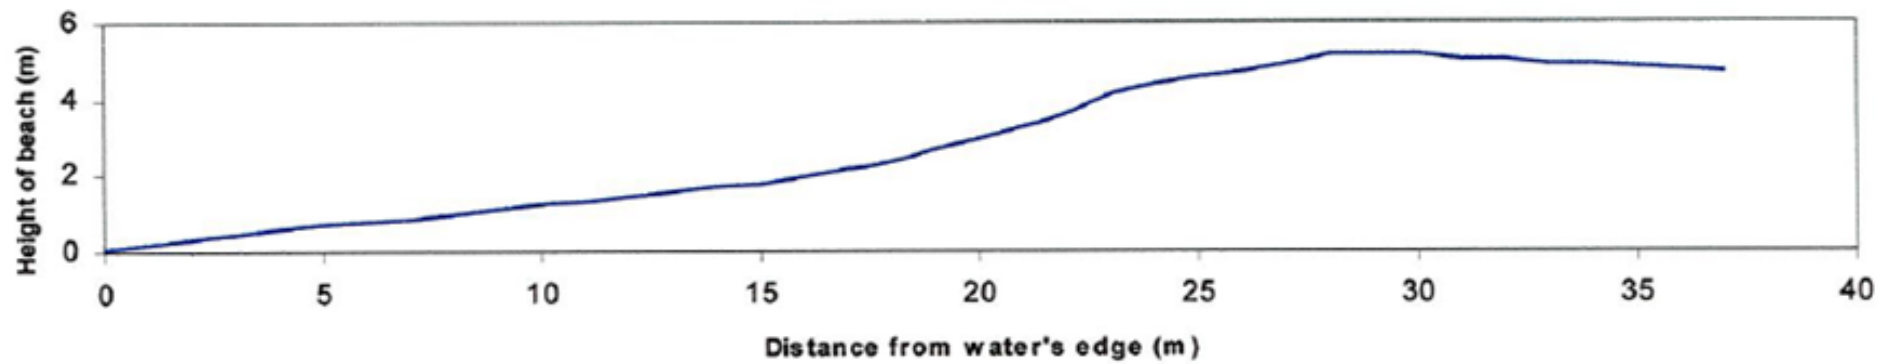
Transect 2. Leveling from water's edge to the road at low tide.

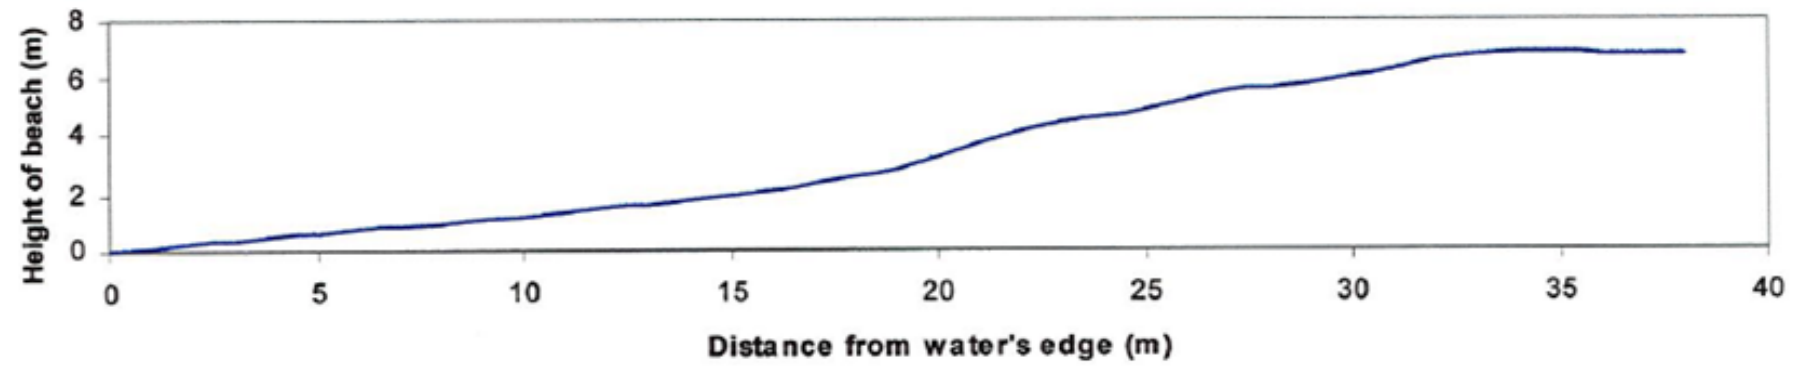
Transect 3. Leveling from water's edge to road at high tide.

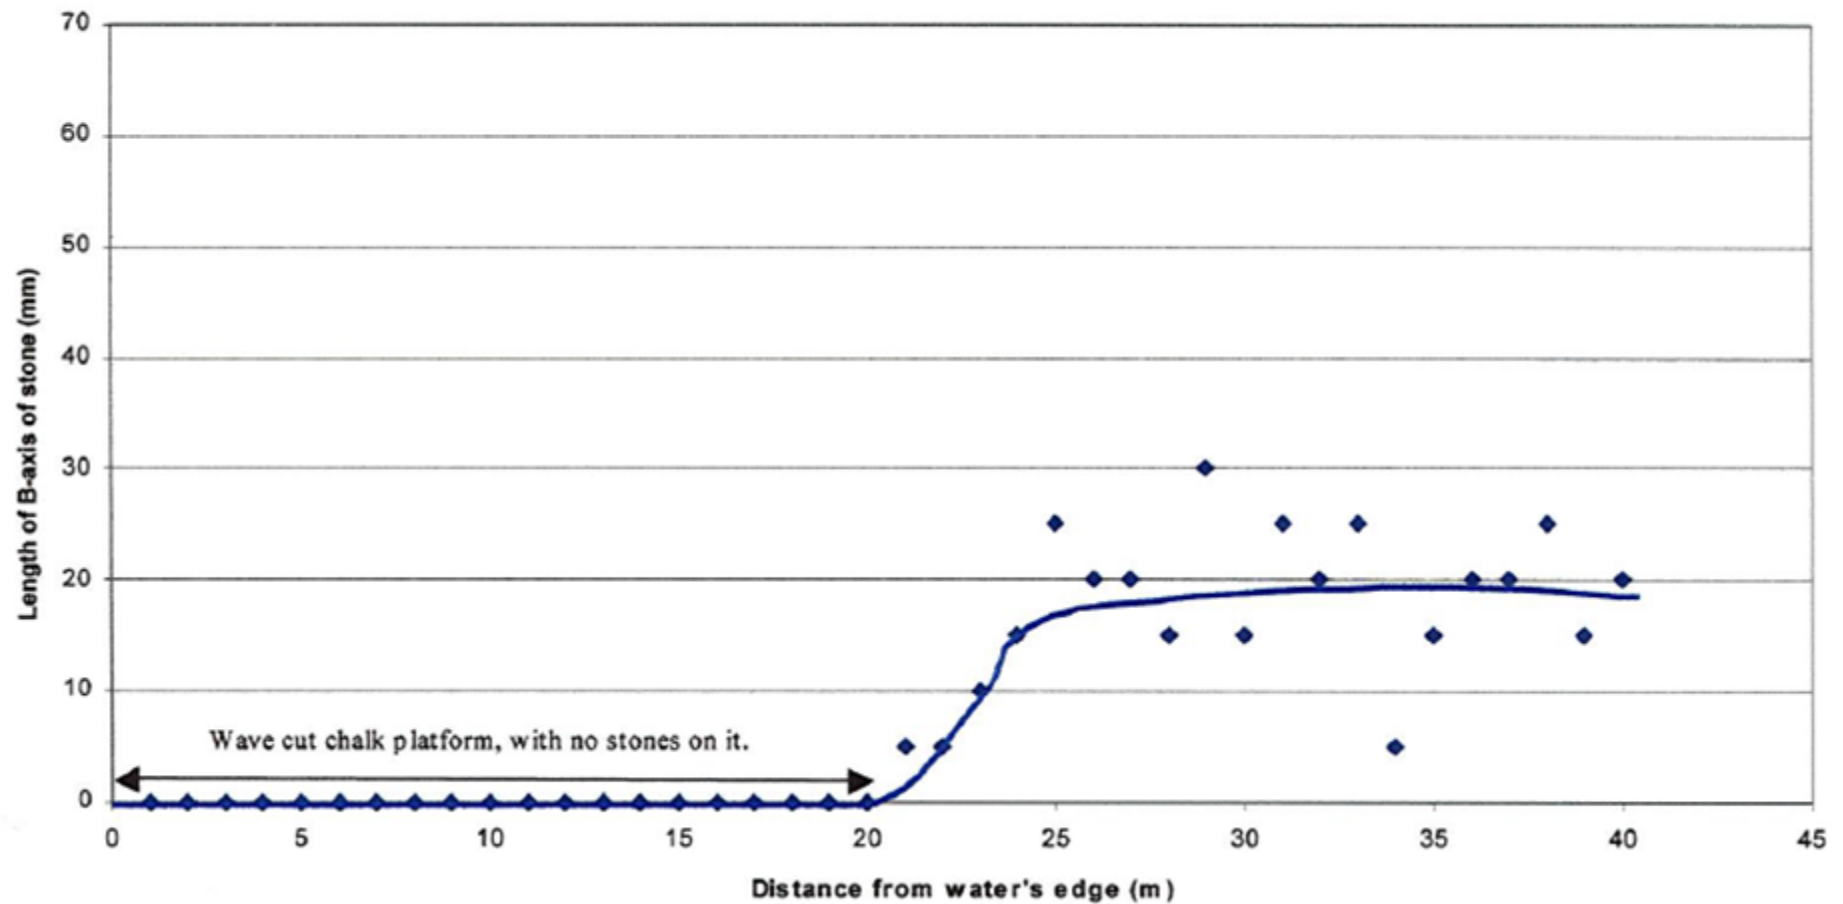
Transect 1. Stone Particle size analysis from water's edge to road at low tide.

The pattern of shingle size on this transect is almost textbook, as would be expected on a natural beach. The shingle increases in size regularly due to attrition breaking and wearing larger stones into smaller stones at the water's edge. However, on this transect the shingle size decreases slightly after the storm ridge, as a result of shingle replenishment at the top of the beach.

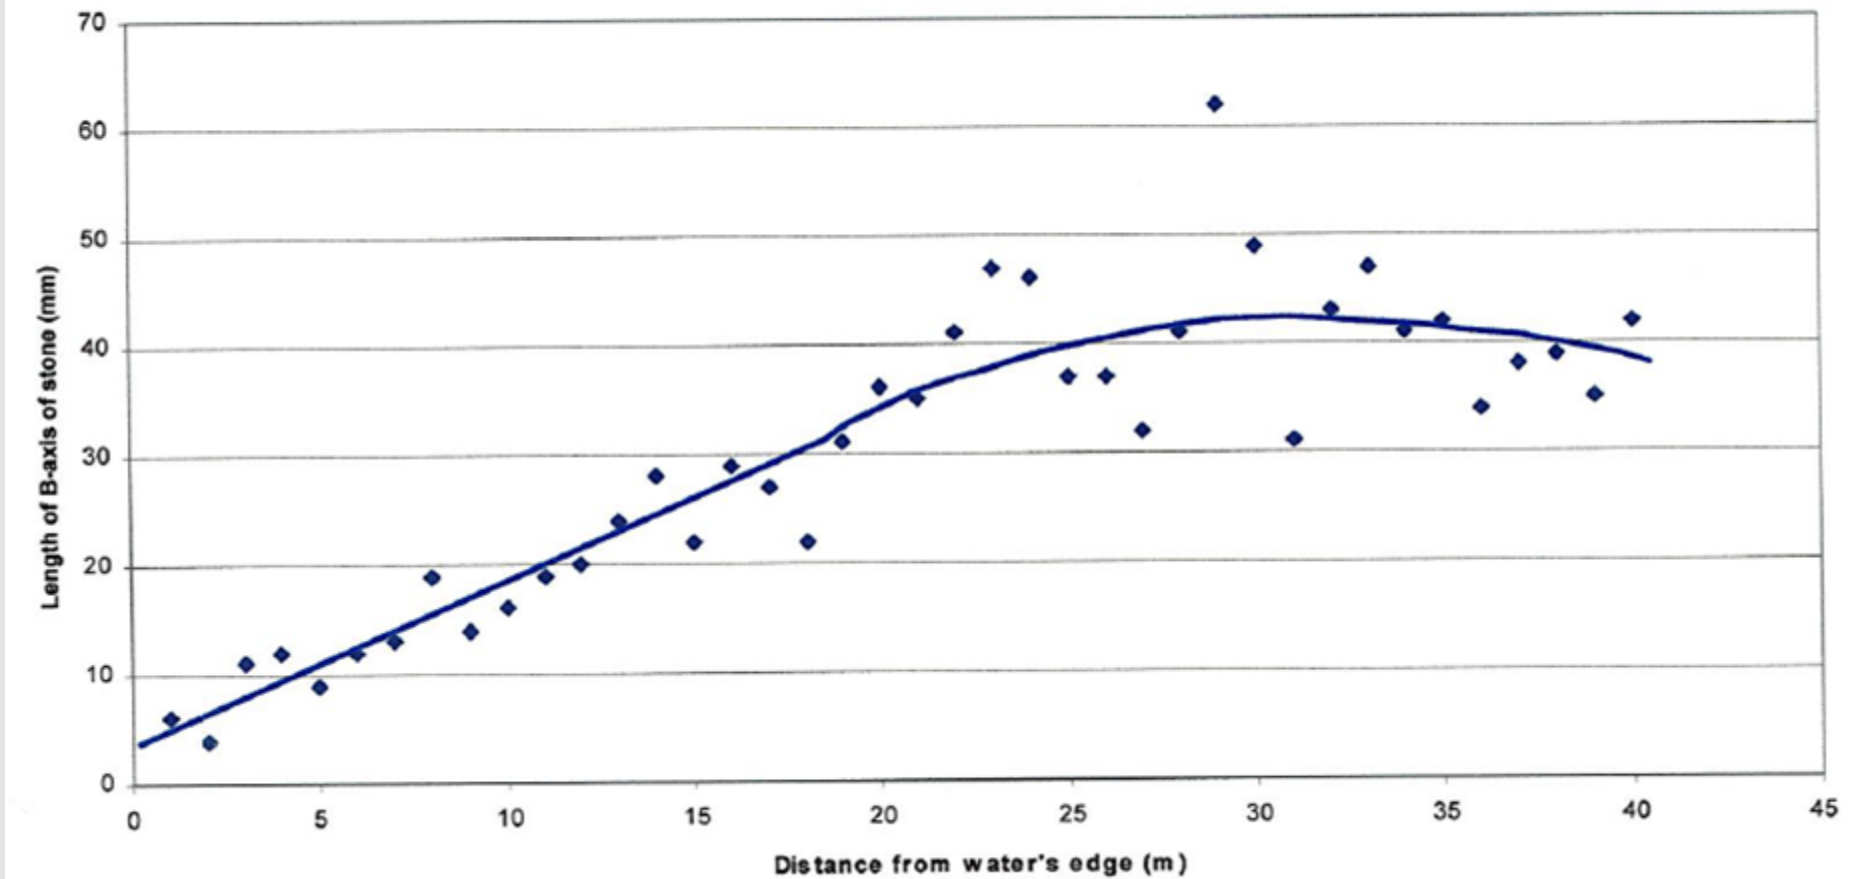
Transect 2. Stone Particle size analysis from water's edge to road at low tide.

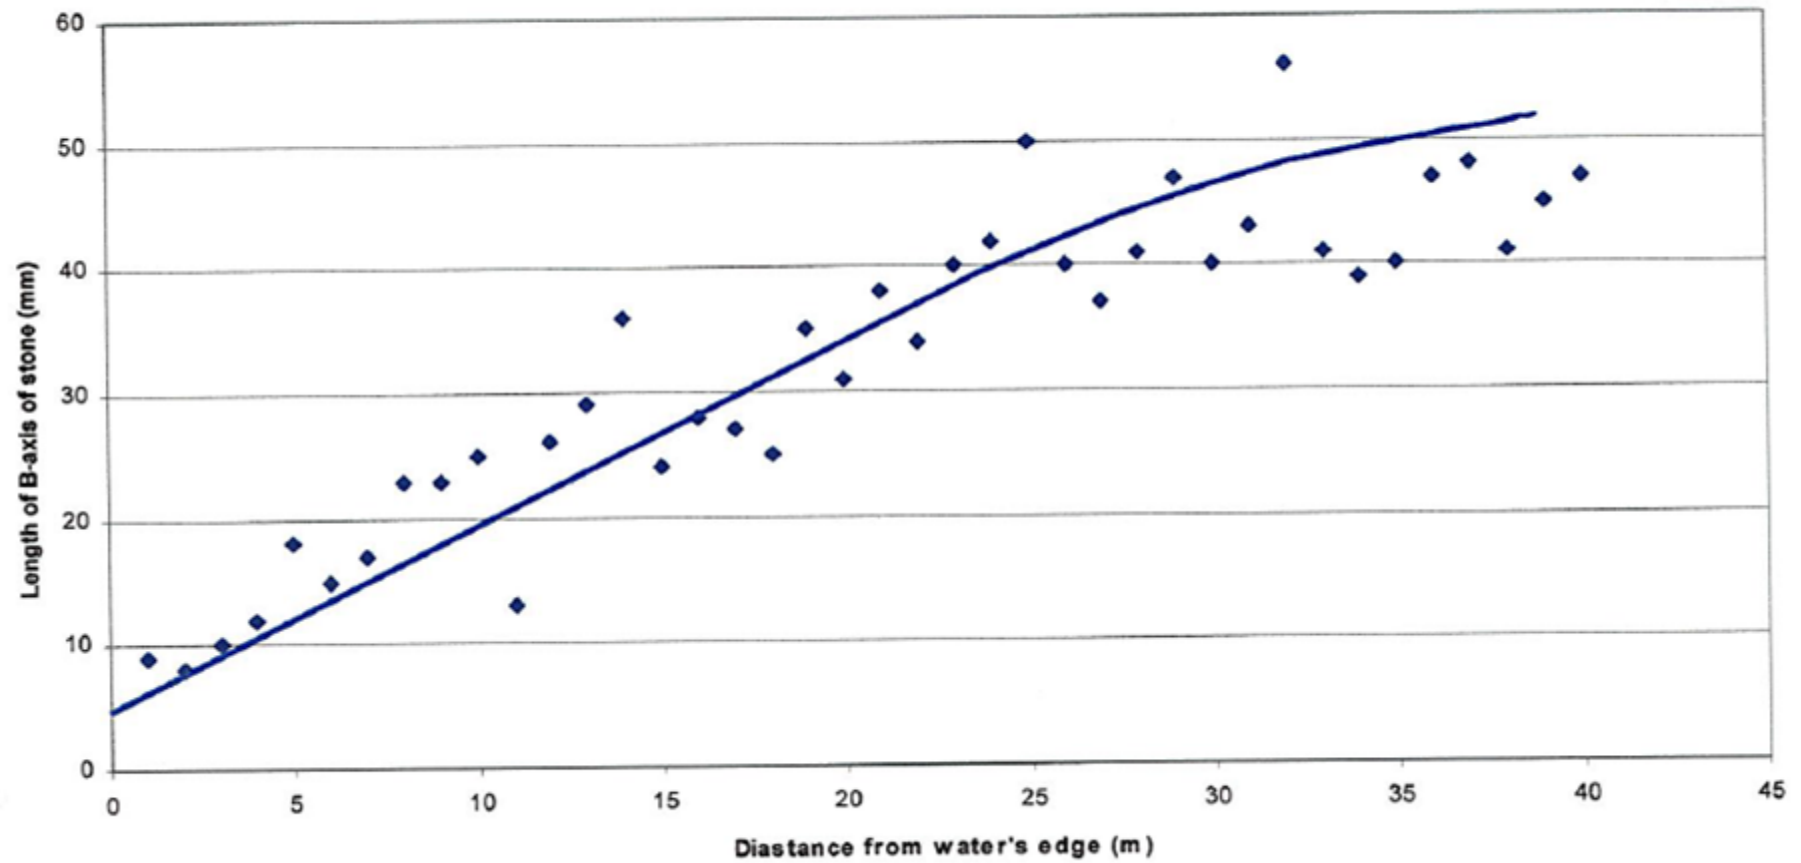
Transect 3. Stone Particle size analysis from water's edge to road at low tide.

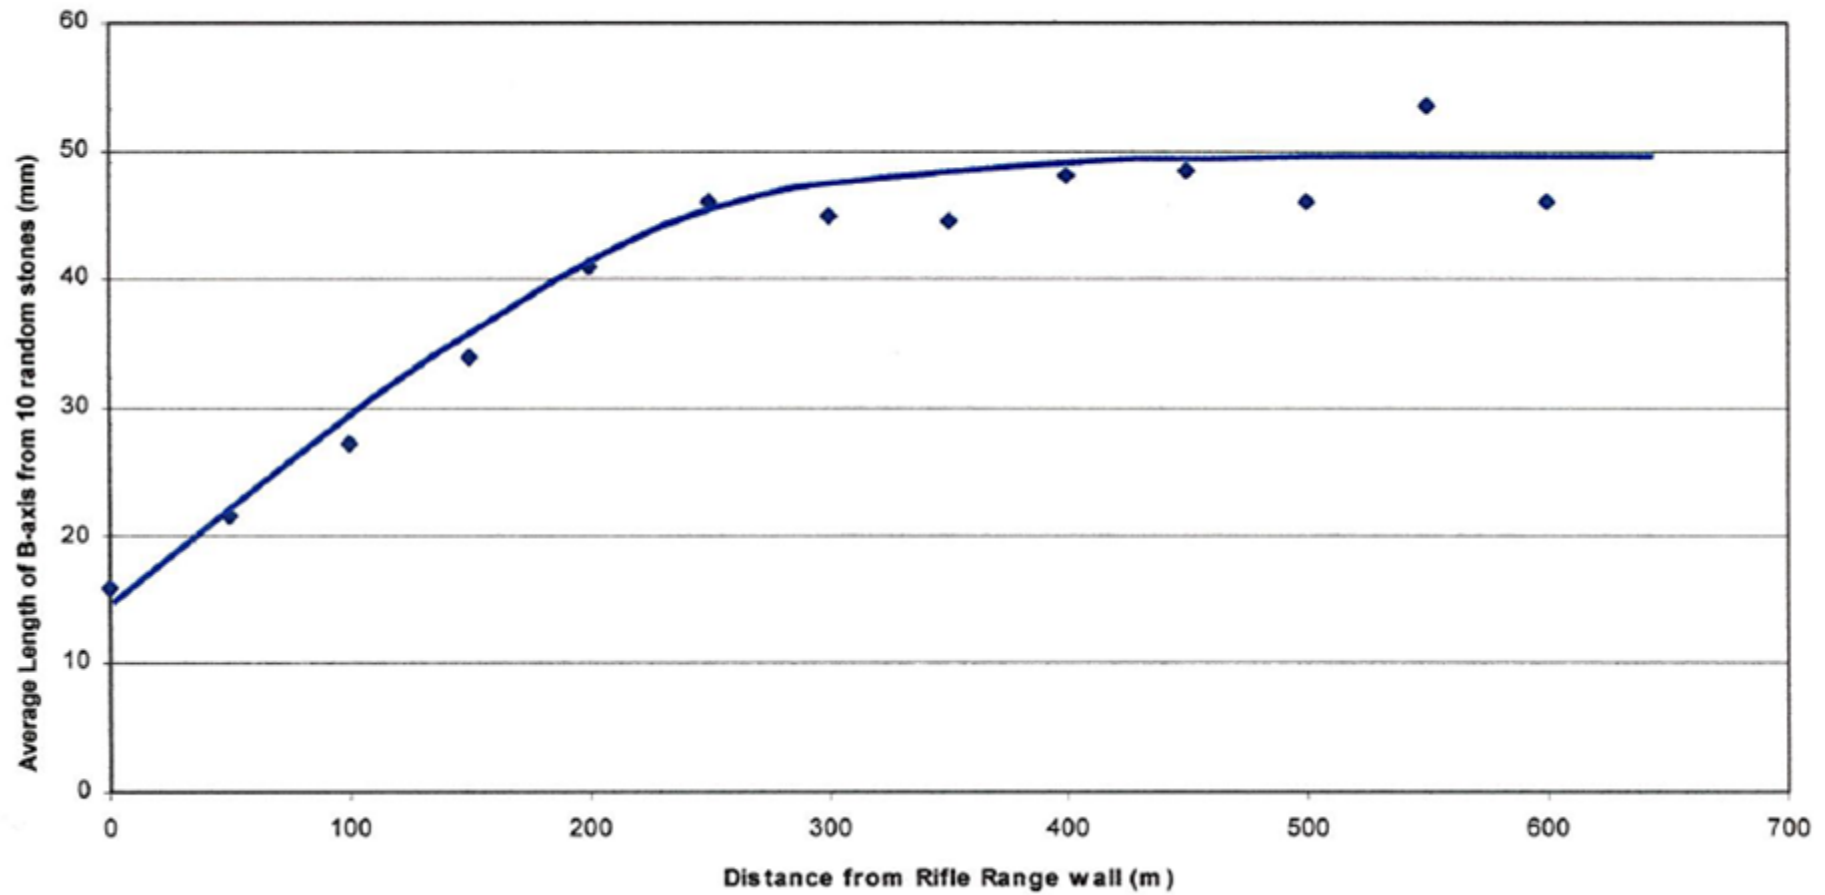
Graph to Show Average Particle Size in relation to the Distance from the Western Rifle Range wall

Two factors account for this pattern: Shingle replenishment has occurred mostly at the southern end of the beach. The imported shingle was mainly of a small size (20mm), hence this reduces the average particle size towards the south of the beach. Further north than the point 200m from the MOD wall is not affected by shingle replenishment, so the shingle size is constant.

Longshore drift has also had an effect. The most powerful movement of materials along this coast is from the south to the north. Therefore the larger material is carried north, away from the southern end of the beach, and the less powerful waves only bring smaller particles back to the south. This results in a net reduction of particle size towards the south of the beach.

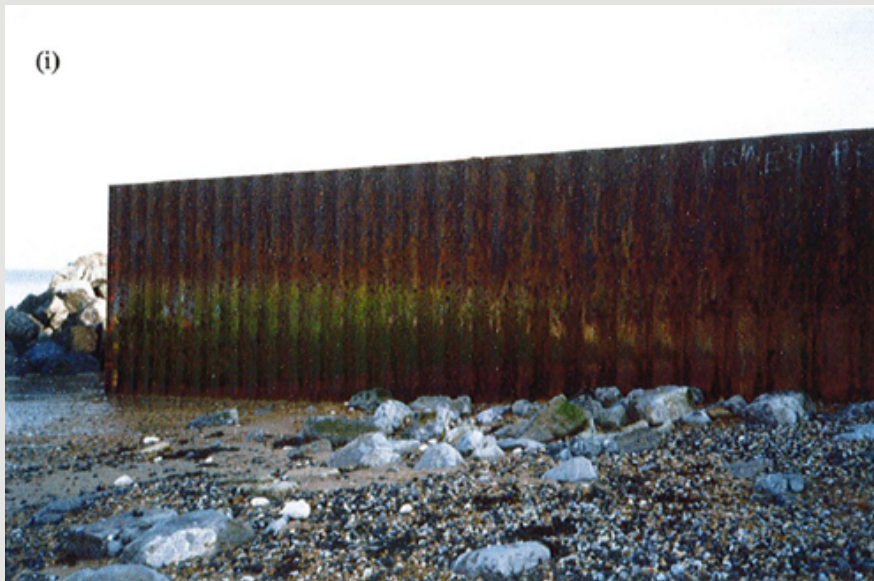
(i) The steel wall in 1997 before storm damage. This wall enclosed Oldstairs Bay and protected it from erosion. This photograph is taken from the seaward side of the wall. Behind the wall rubble is mounted.

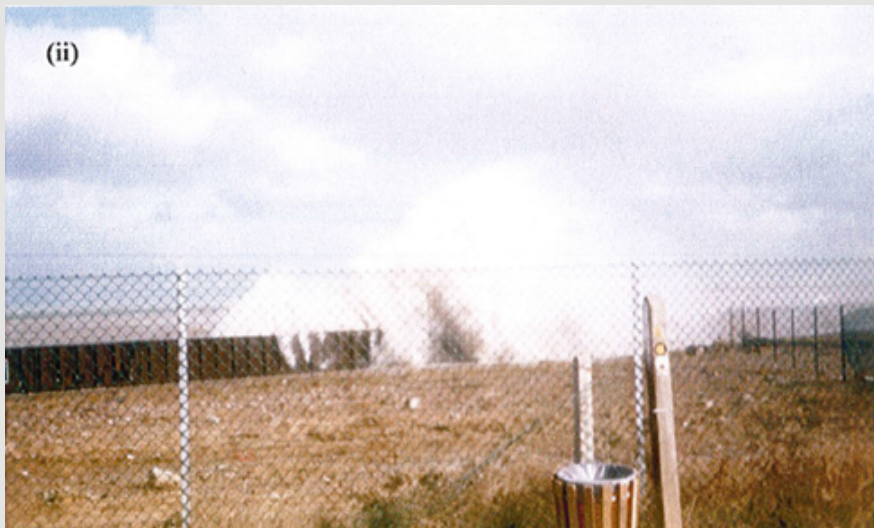
(ii) The steel wall from the landward side, in February 1998 during the storm which destroyed it. The heavy shingle content of huge waves pounded the wall into pieces.

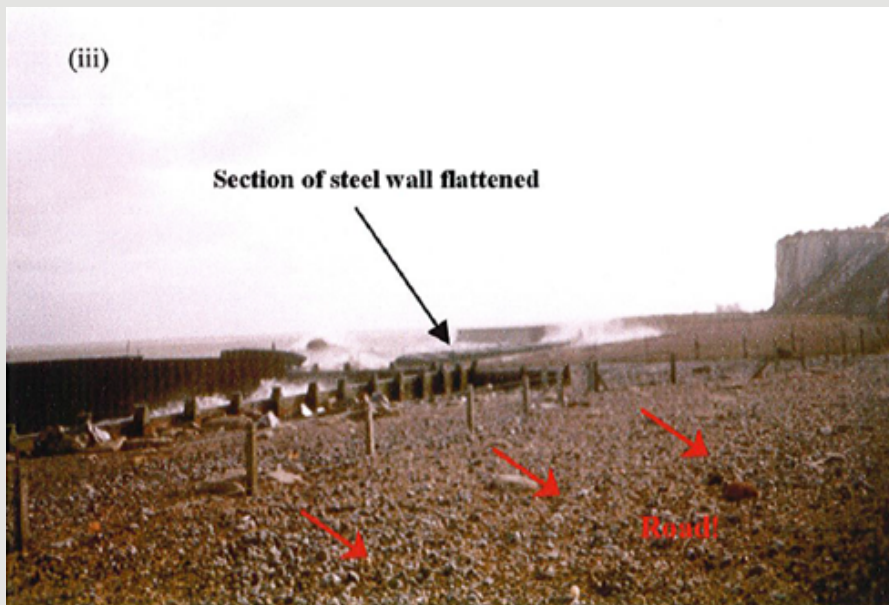
(iii) Also During the storm, this photograph (looking south along Oldstairs bay) shows how the wall has been buckled by the storm and eventually flattened. The waves are now free to advance up the beach. Note that on the unprotected beach north of the metal wall has allowed shingle to be thrown up onto the road. This storm closed the road for four days and caused thousands of pounds worth of damage. This was mainly due to the narrowness of the beach.

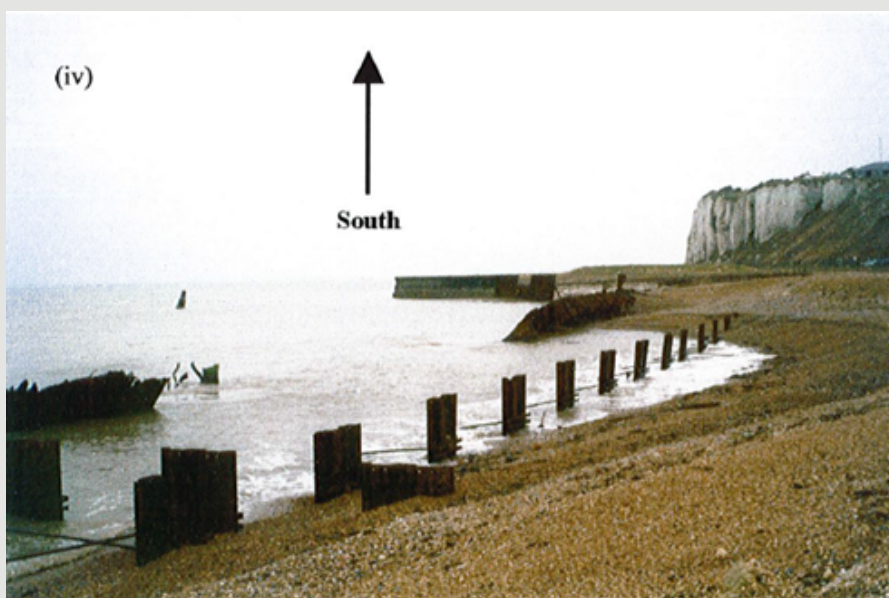
(iv) One month after the storm, the metal has been completely destroyed and removed by the sea. Note also that the sea has immediately encroached onto the previously dry land, forcing the bay to open up closer to the road. Within a month of unusallu bad weather the sea has already advanced more than 10m inland.

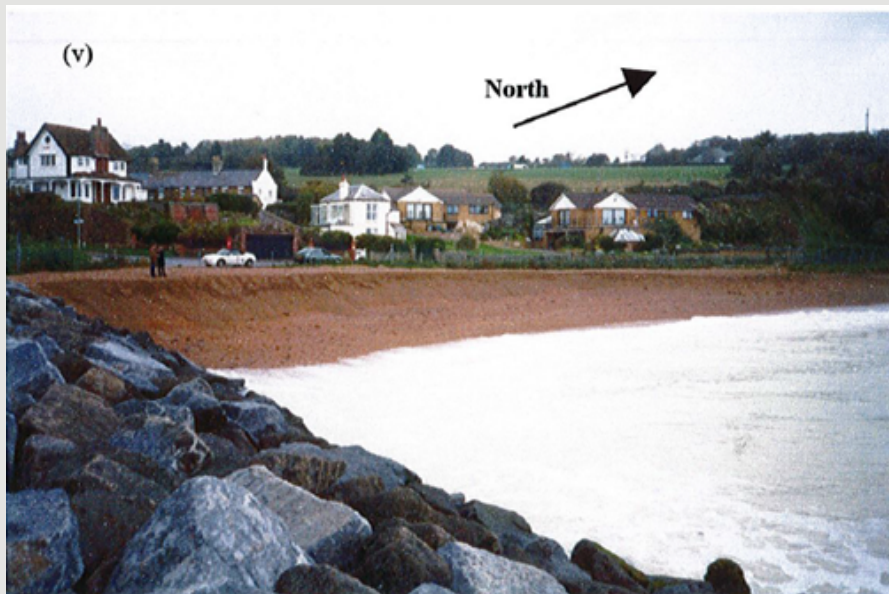
(v) This is Oldstairs Bay in September 2000. In the background is the housing and the road endangered by the advancing sea. In the foreground is the rock revetment built to replace the metal wall. During the 30 months since the storm the bay has retreated about 40m, despite the revetment.

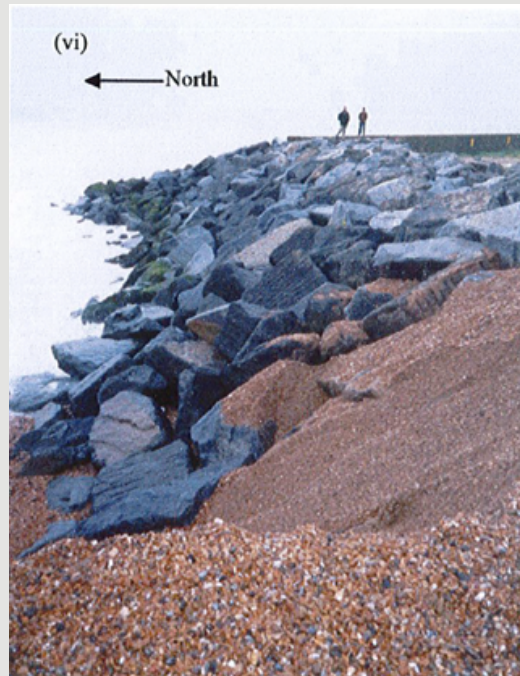
(vi) This is rock revetment built in 1998 to protect the bay. It runs perpendicular to the beach at the south of the Oldstairs Bay.

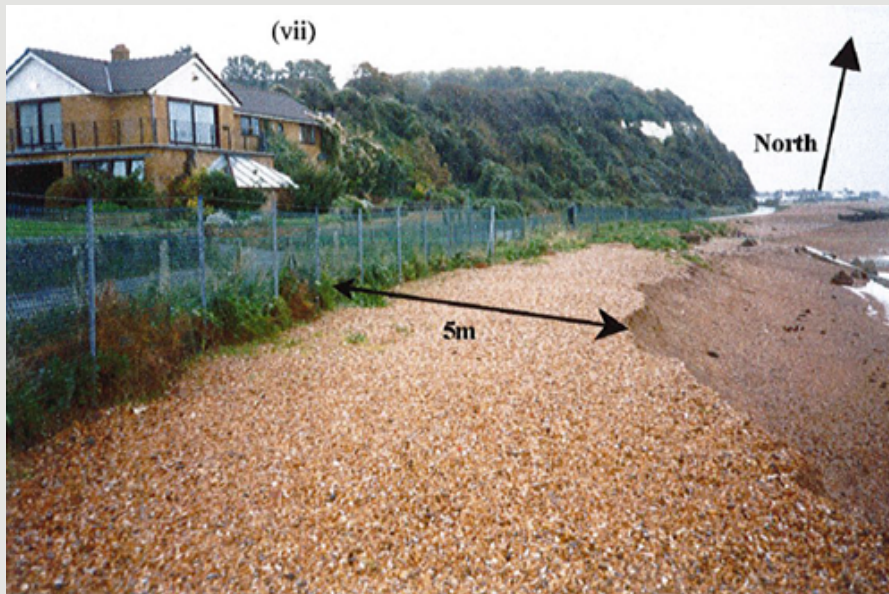
(vii) The shingle at the top of the bay. The road is only 5m from the top of the shingle ridge. This distance could easily be covered by storm waves.

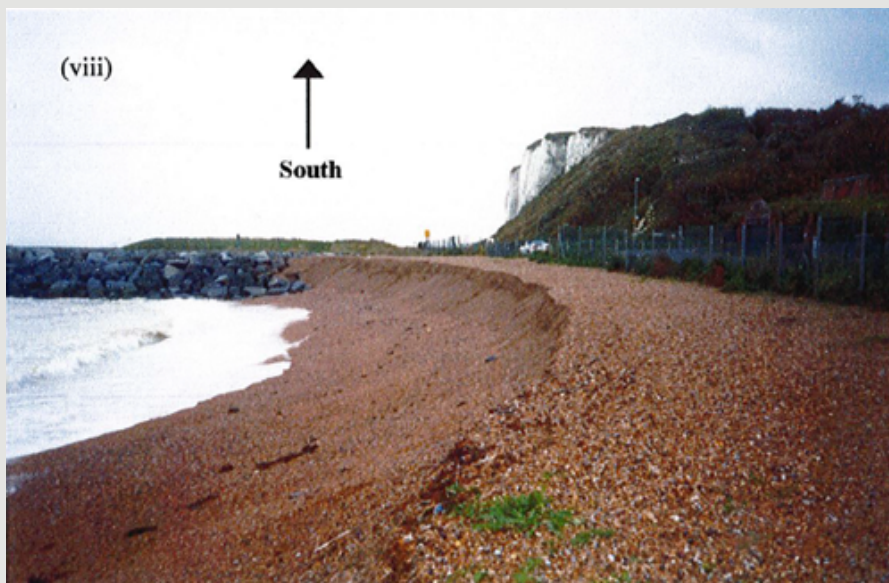
(viii) The bay has been exaggerated. This part of the beach is now extremely narrow. There is a very small mass of shingle left in the bay.

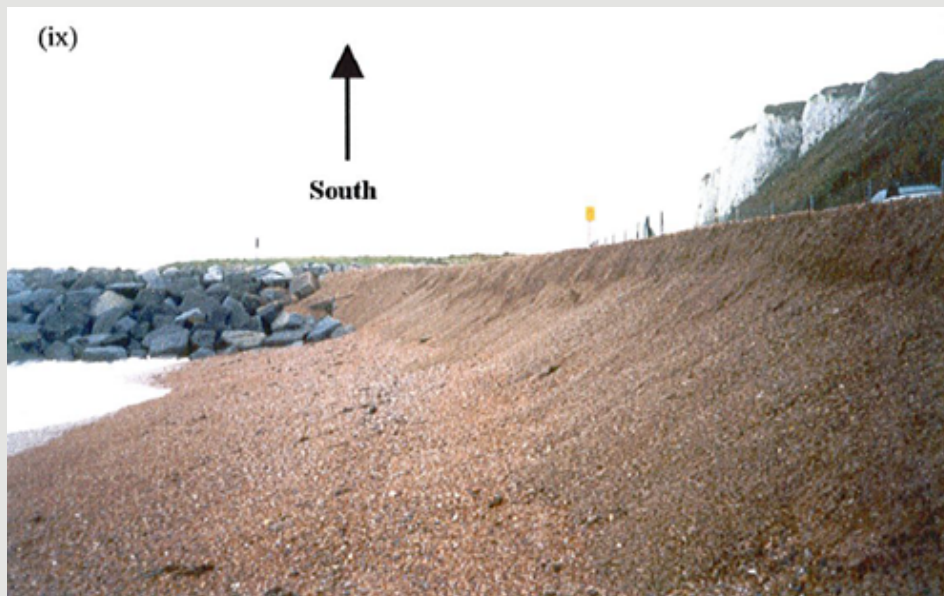
(ix) An extremely steep and unstably shingle ridge (approximately 2.5m high) has developed at the top of the beach. The steepness is caused by repeated undercutting.

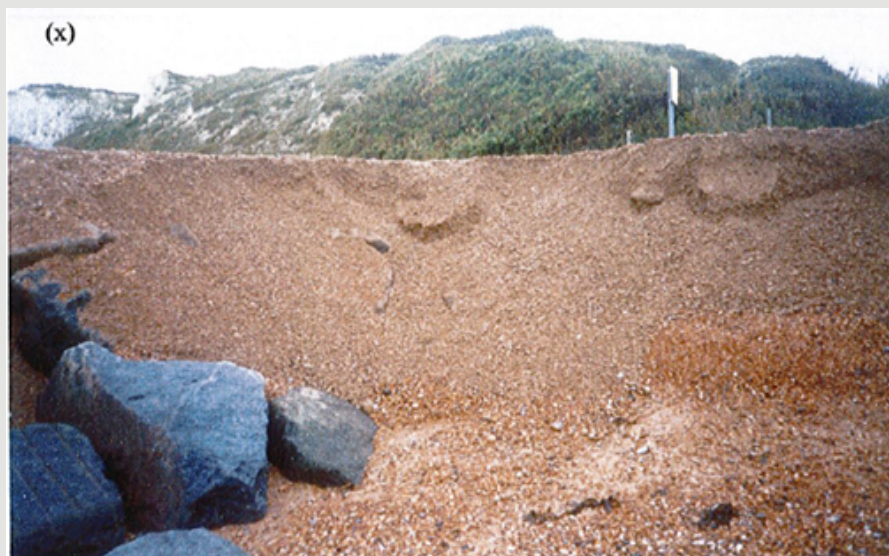
(x) Evidence of recent collapse of the shingle ridge is shown here. This ridge is so unstable that it collapses beneath gentle pressure from a foot.

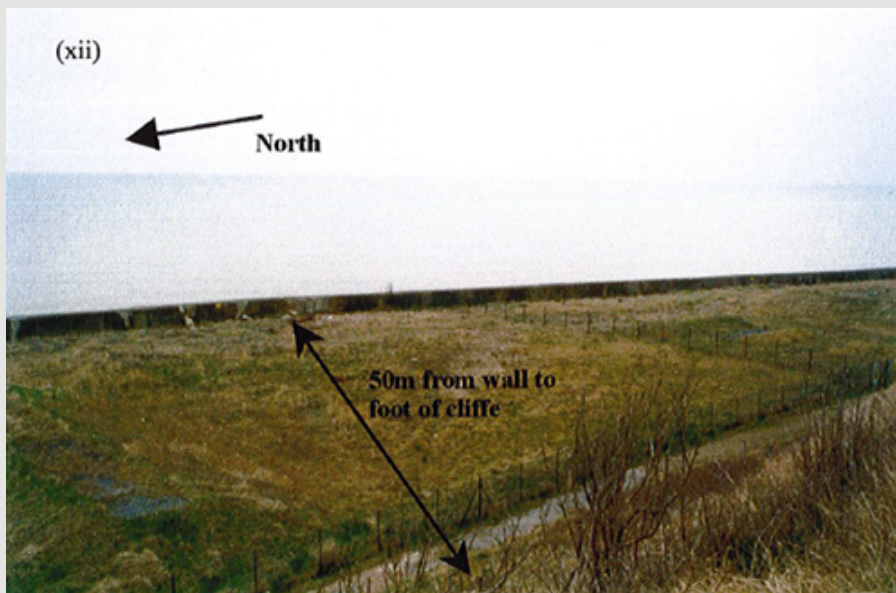
(xii) Looking down from the cliff top, this is the area of MOD property south of Oldstairs Bay. The wall has been there for over 40 years, and all beach material has been removed from in front of it. This piece of land jutting out from the cliff acts as a barrier to movement of shingle southwards to replenish Oldstairs Bay.

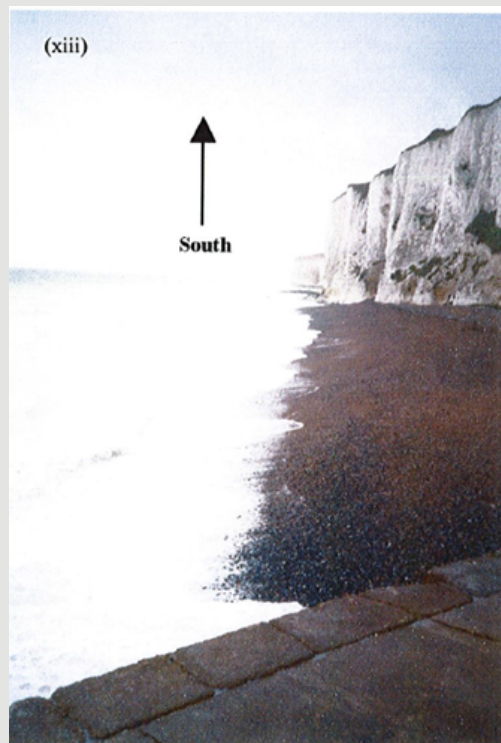
(xiii) At the southern tip end of the MOD sea wall, over 1km south of Oldstairs Bay, this beach is the nearest source of shingle to be carried north by LSD and Replenish Kingsdown Beach.

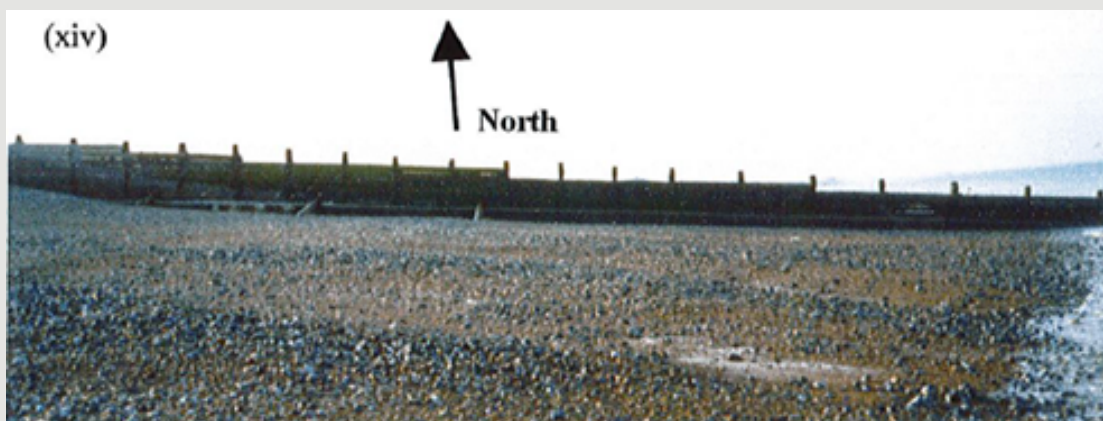
(xiv) In the middle section of Kingsdown Beach, about 500m north of Oldstairs Bay, this is a new wooden groyne (at low tide) in 1995.

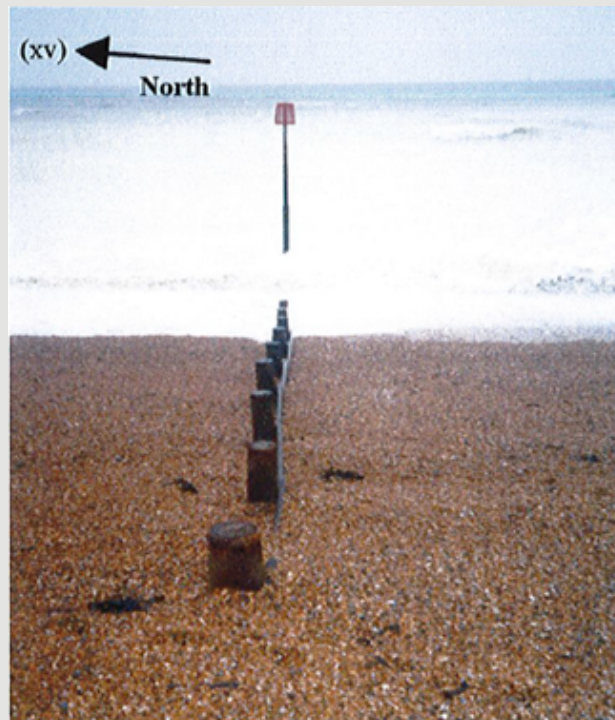
(xv) This is the same groyne (at high tide) in August 2000. Southward movement of material due to longshore drift has overwhelmed and buried relatively new groynes.

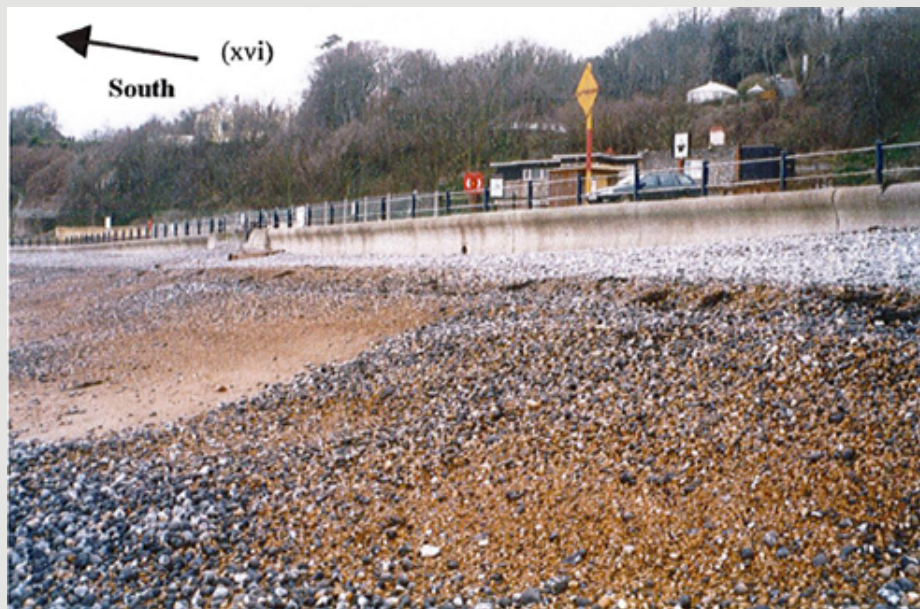
(xvi) At the north end of the beach this sea wall in 1998, built to protect housing behind it.

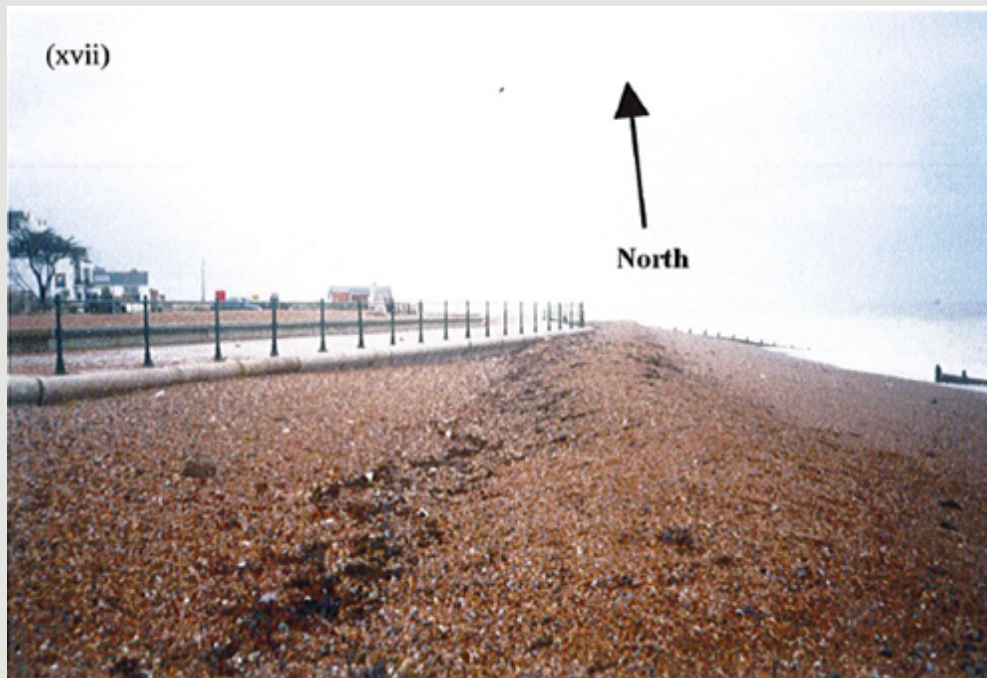
(xvii) This is the same sea wall (from a different perspective) in August 2000. The height of the shingle against the wall has risen about 1m. The shingle has come from the Oldstairs Bay end of the beach.

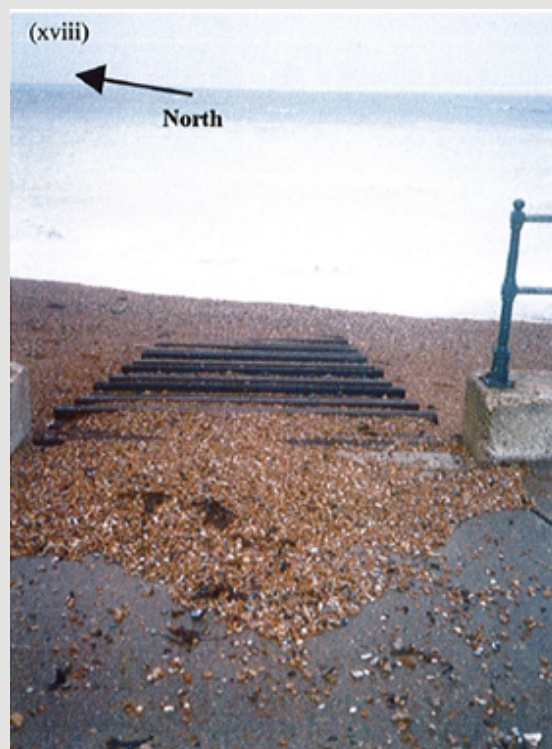
(xviii) The boat ramp at the north end of the beach was built in 1995. Photographed here in September 2000, it has almost been completely buried by shingle from the south.
